# Merriwether-Cherokee Potamology Study

MRG&P Report No. 9 • May 2017

# **Merriwether-Cherokee Potamology Study**

Brian M. Hall, Roger A. Gaines, L. Yu Lin, and Kandi H. Waller

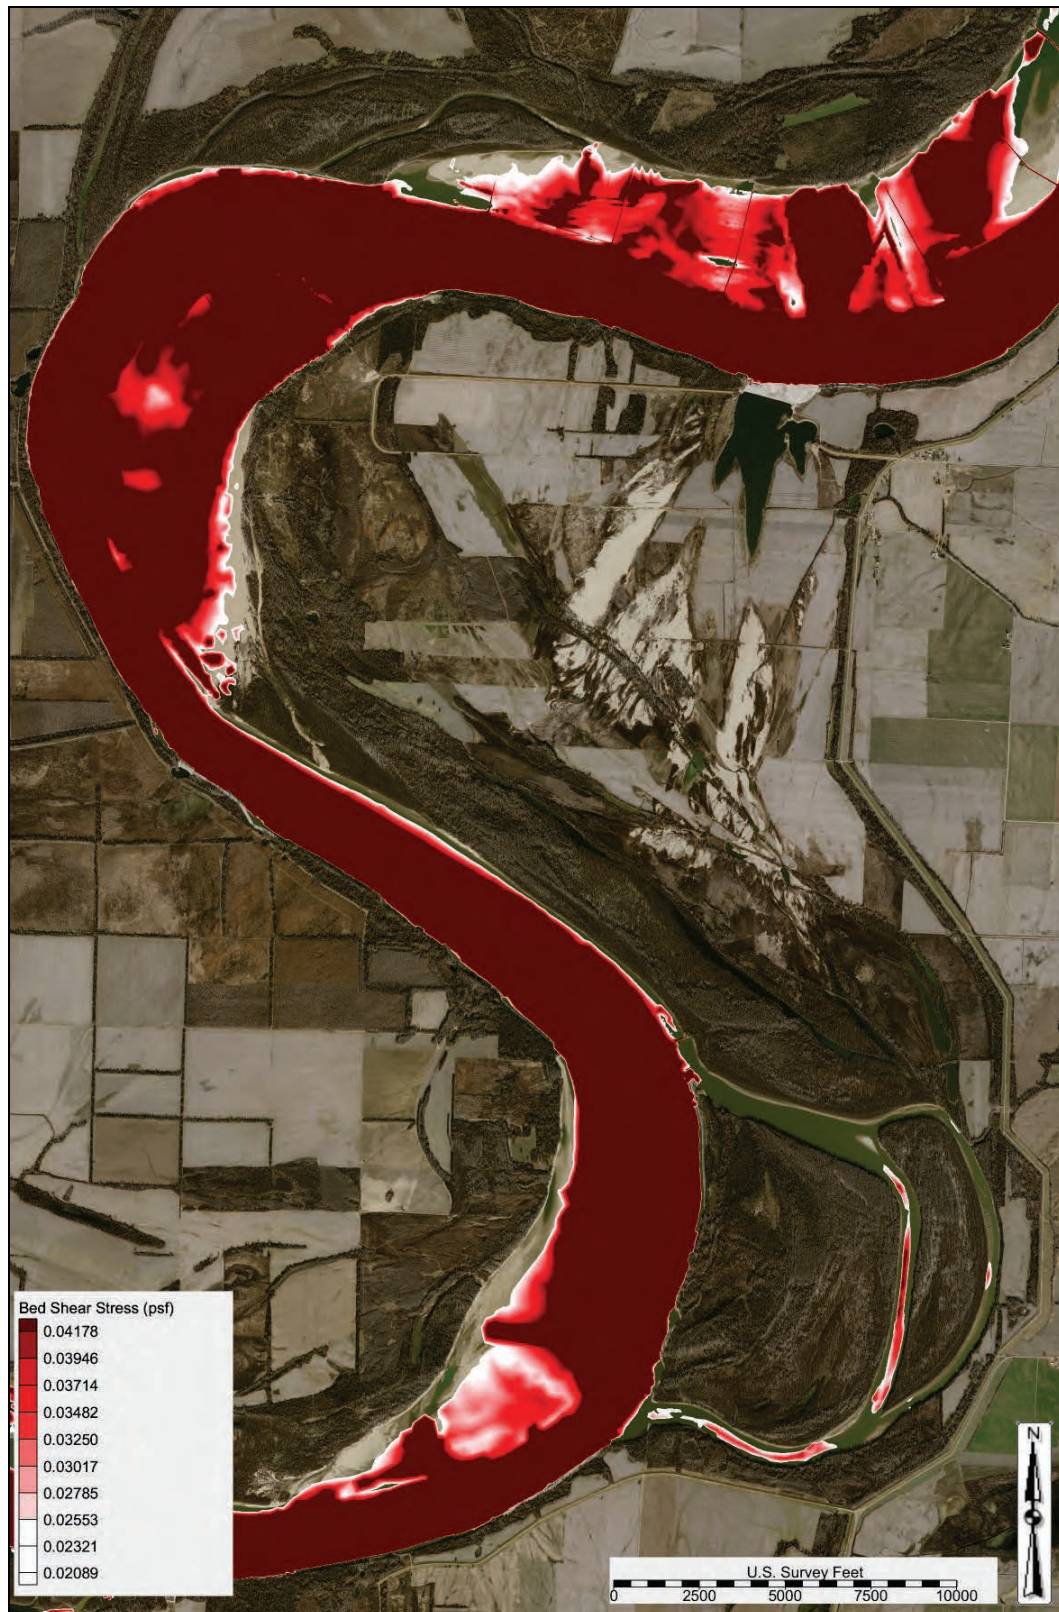
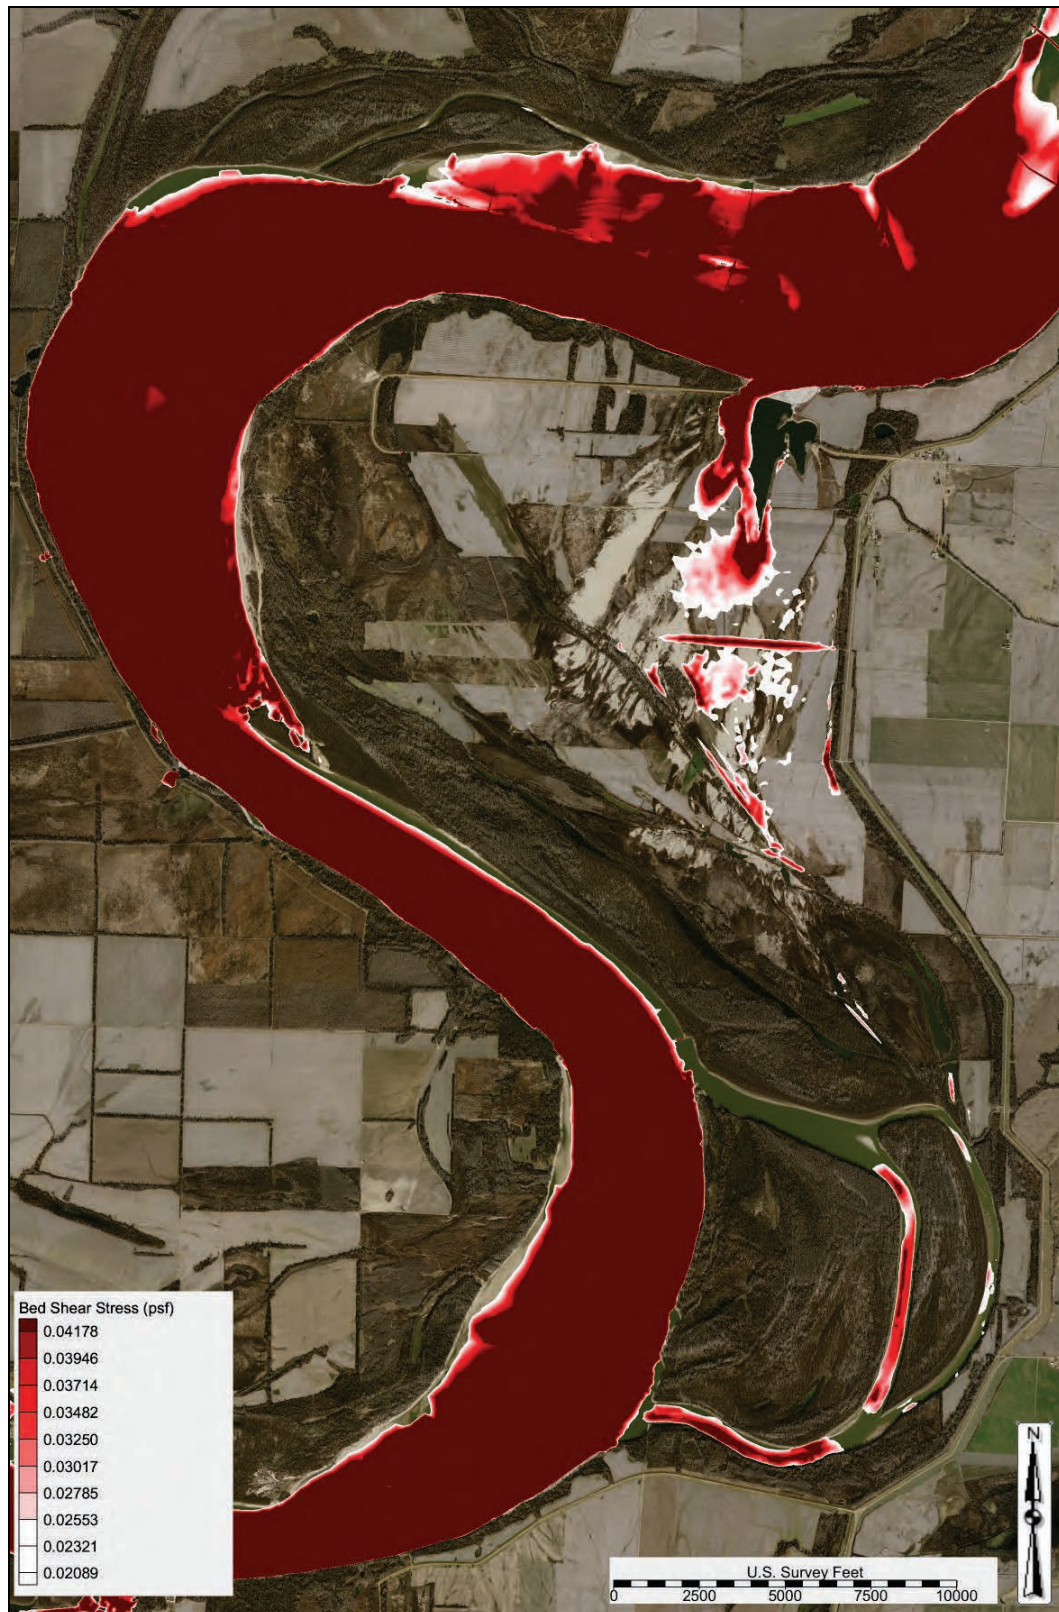
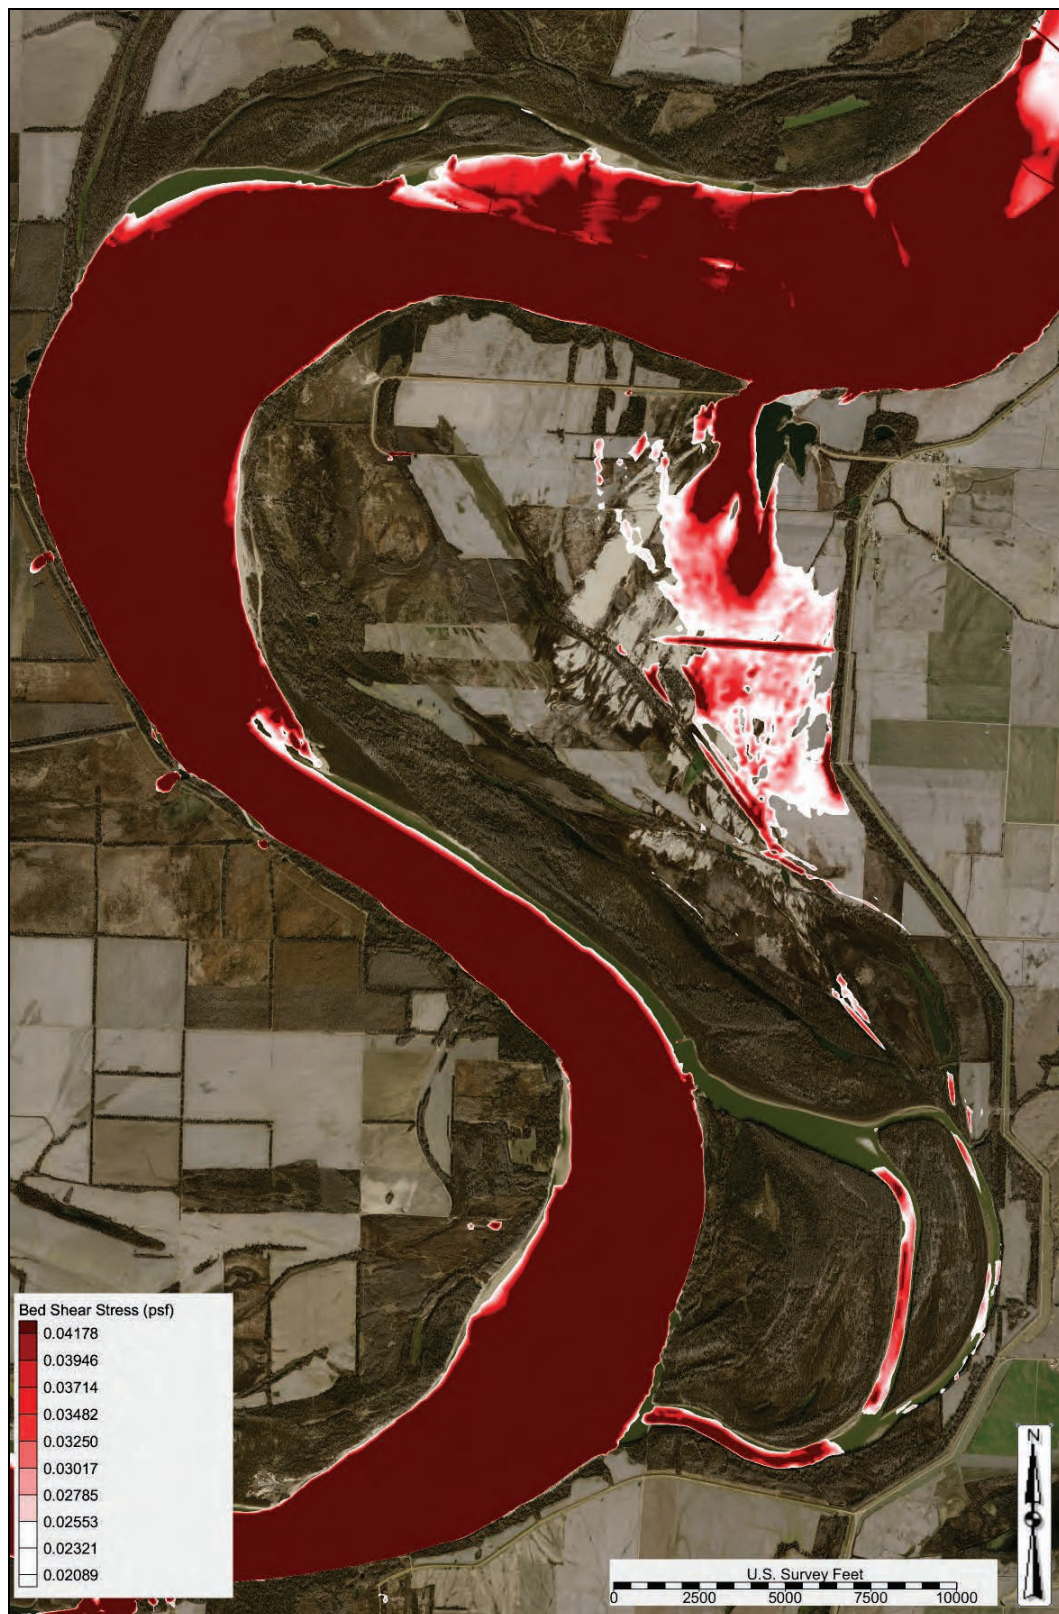
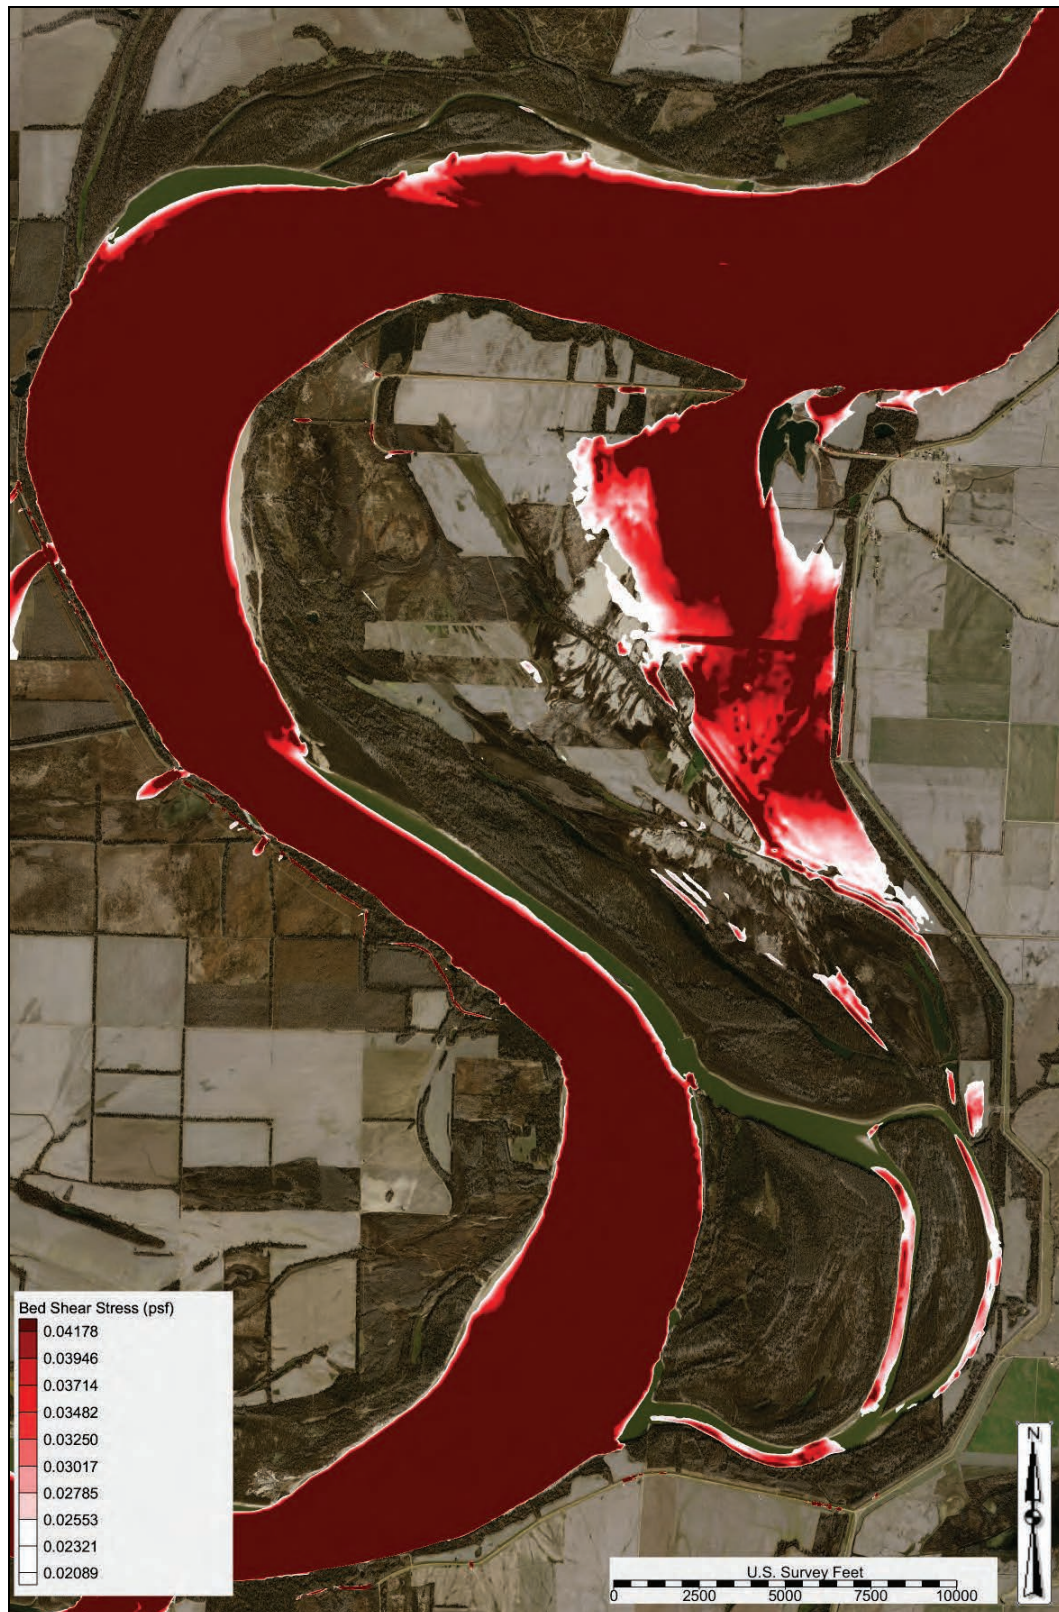
Figure C-95. Closure structure failure shear stress—900,000 cfs (study overbank).

Figure C-97. Closure structure failure shear stress—1,300,000 cfs (study overbank).

Figure C-98. Closure structure failure shear stress—1,500,000 cfs (study overbank).

Figure C-99. Closure structure failure shear stress—1,700,000 cfs (study overbank).

Figure C-100. Closure structure failure shear stress—1,900,000 cfs (study overbank).

Figure C-101. Closure structure failure shear stress—2,100,000 cfs (study overbank).

The modeled shear stress outputs at flows ranging from 900,000 to 2,100,000 cfs for the study overbank are depicted in Figures C-95 through C-101.

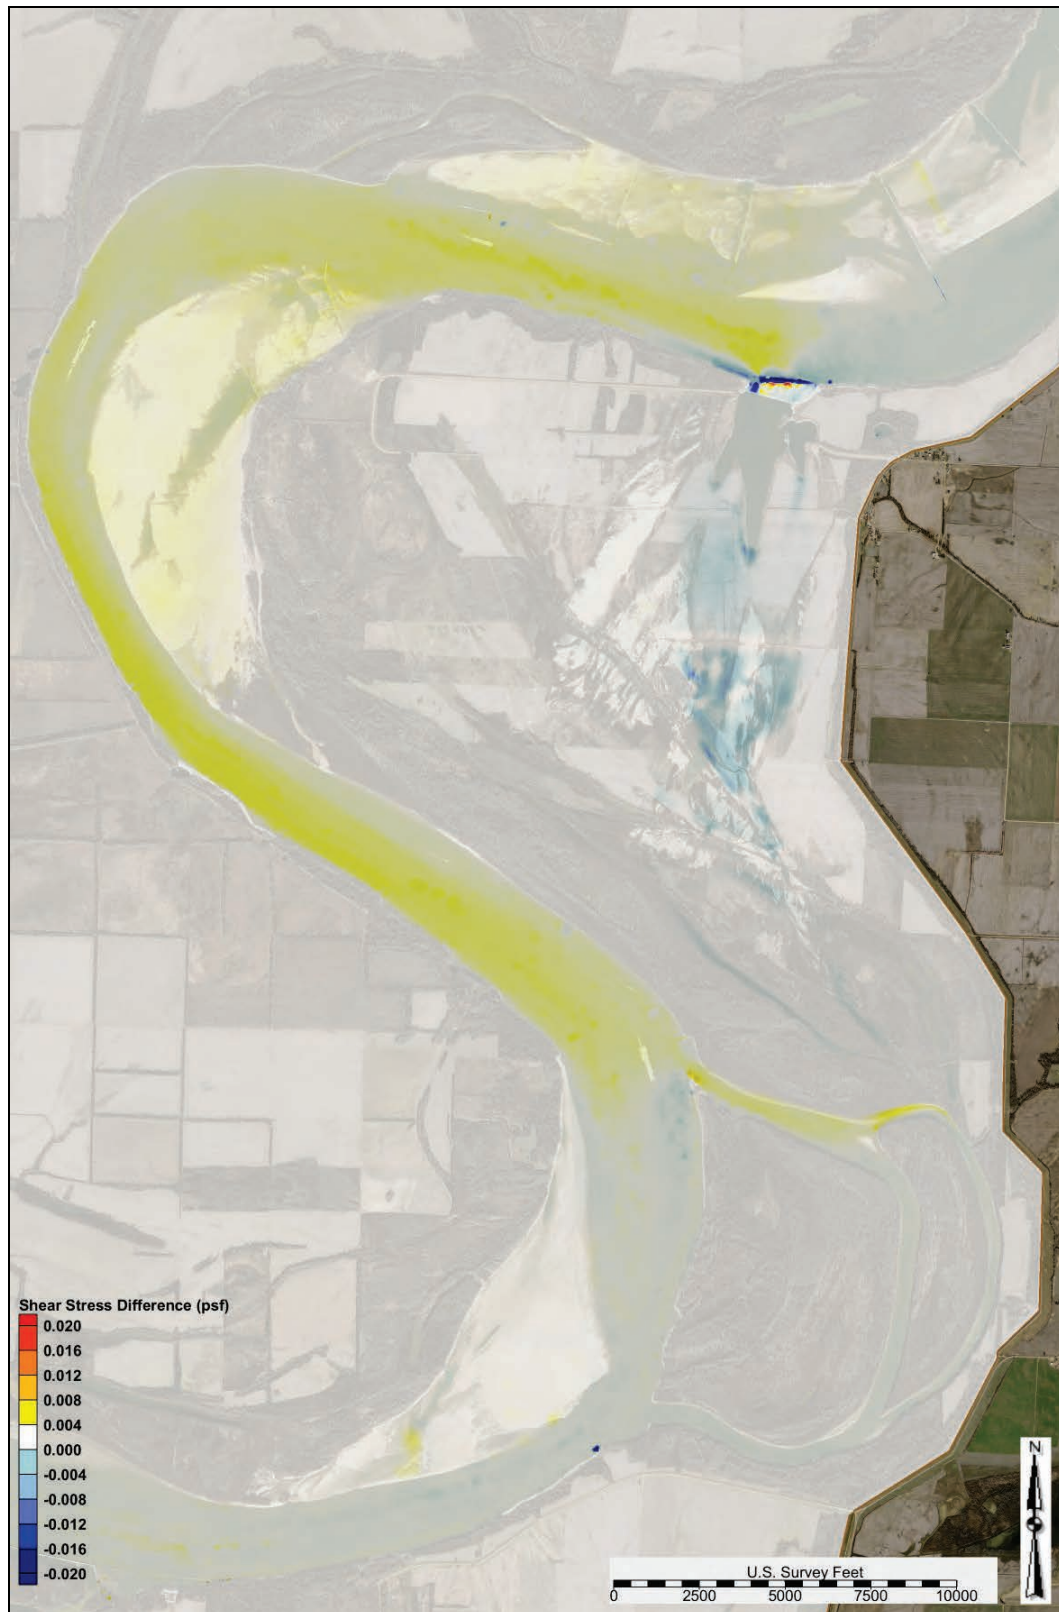
Figure C-121. Alternative 1 shear stress difference—900,000 cfs.

The modeled shear stress difference plots compared to the base condition output for flows ranging from 900,000 to 2,100,000 cfs are depicted in Figures C-121 through C-127. A positive shear stress difference (+ value and red and orange) indicated an increased shear stress compared to the base condition. A negative shear stress difference (- value and blue) indicated a decreased shear stress compared to the base condition. A zero shear stress difference (zero value and white) indicated that the alternative had no change in shear stress.

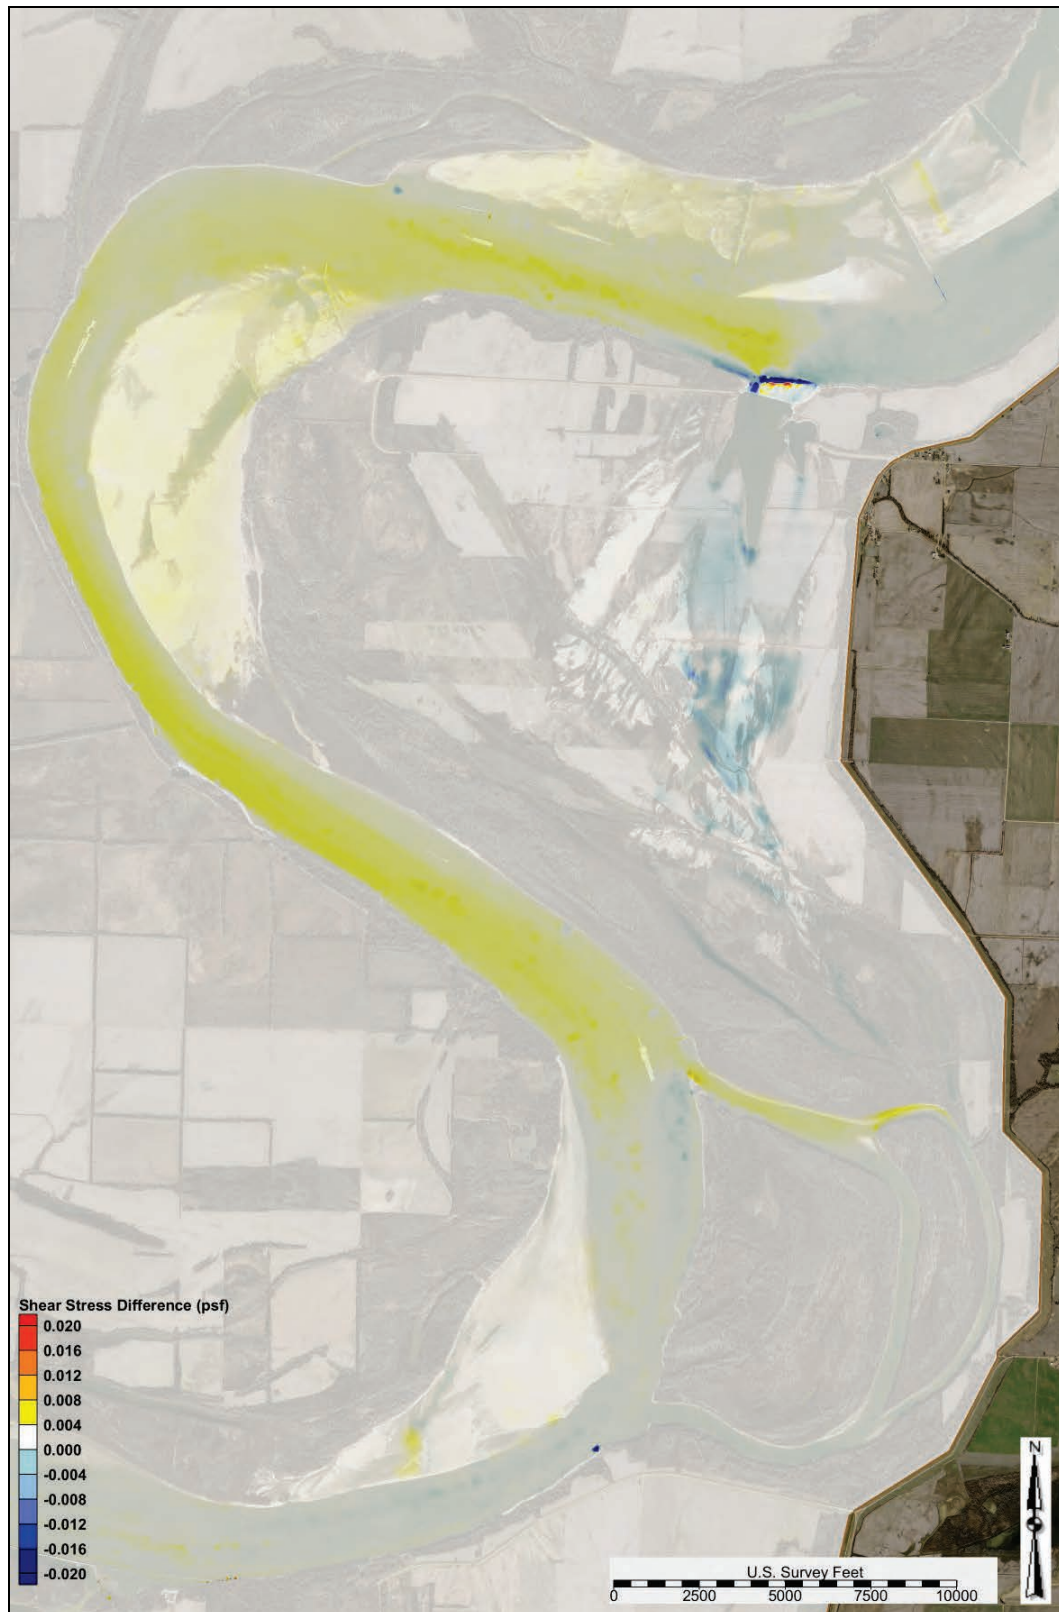
Figure C-136. Alternative 2 shear stress difference—900,000 cfs.

The modeled shear stress difference plots compared to the base condition output for flows ranging from 900,000 to 2,100,000 cfs are depicted in Figures C-136 through C-142. A positive shear stress difference (+ value and red and orange) indicated an increased shear stress compared to the base condition. A negative shear stress difference (- value and blue) indicated a decreased shear stress compared to the base condition. A zero shear stress difference (zero value and white) indicated that the alternative had no change in shear stress.
